# What is stability of the lifted load?

**Richard Krabbendam** investigates the possible cause of an unexplained accident in which a gas turbine rotor was dropped during a lift by a special spreader beam.

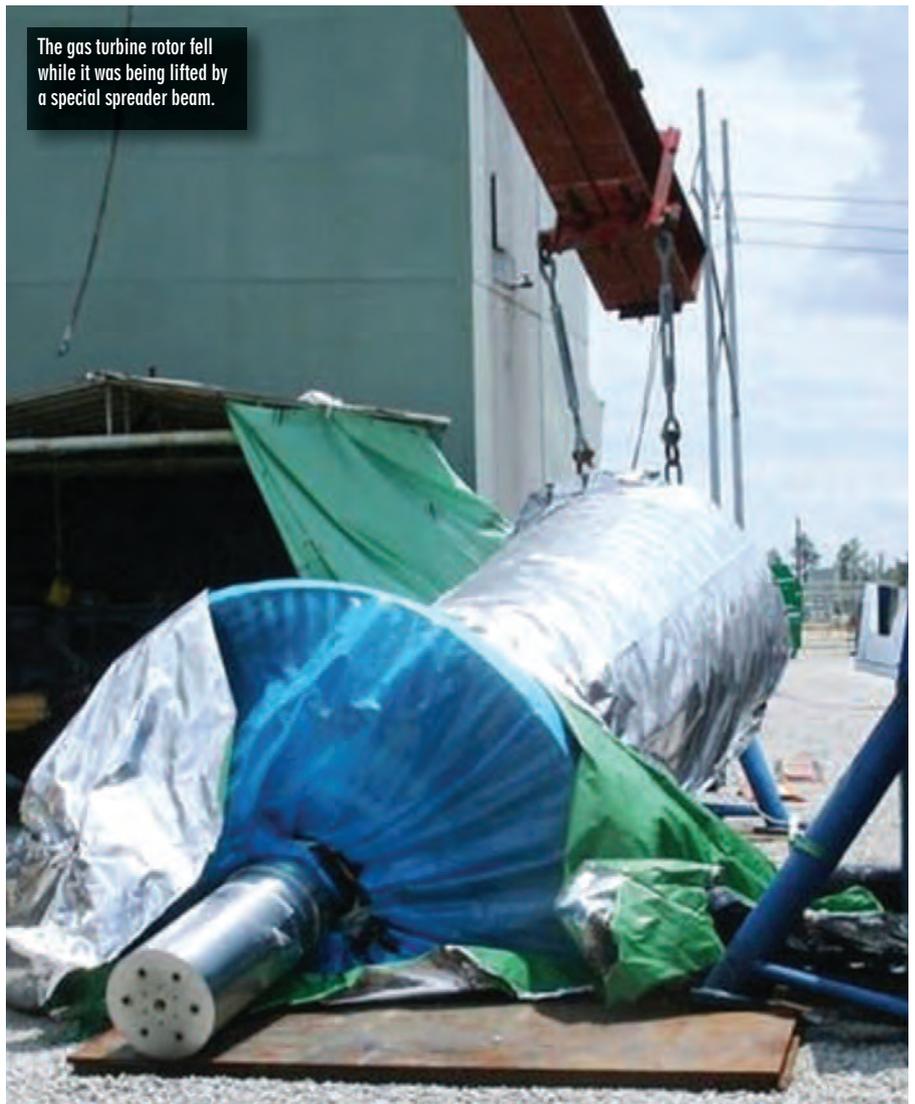
Recently investigated the reason a gas turbine rotor fell while it was being lifted by a special spreader beam, as shown in the picture (right).

Fortunately nobody was hurt, but the damage done to the balanced rotor was significant.

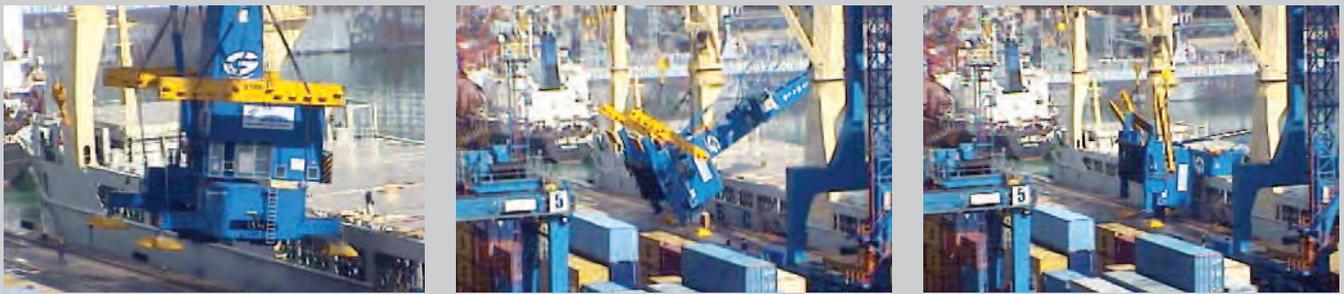
A sequence of shots showing a mobile port crane being lifted from the outriggers of the crane using a lift beam with insufficiently long slings.

could be in for a nasty surprise – as pictured above, where a mobile port crane was lifted from the outriggers of the crane using a lift beam with insufficiently long slings.

Apparently, the CoG of the crane was only barely enclosed by the lift triangle, projected down to the lift points at the outriggers. Although ostensibly a stable lift, in fact it had very little stability.

During the lift, a sudden external force on the crane made it unstable, causing it to tip and land on the quayside and the heavy lift vessel.
